Manhole Inspection Summary

Manhole # S15W__006MH

Insp Date: **5/14/09 2:38 PM**

Location Address: **2915 WILMARCO AVE**

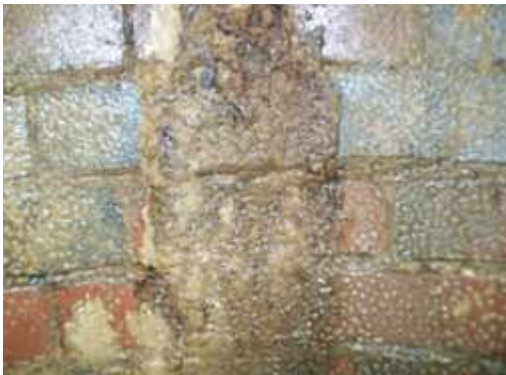
Defect 3

Infiltration: ☐ None ☐ Joint ☐ Cracks ☐ Mortar ☐ Roots ☒ **Wall**

BARREL WALL INFILTRATION

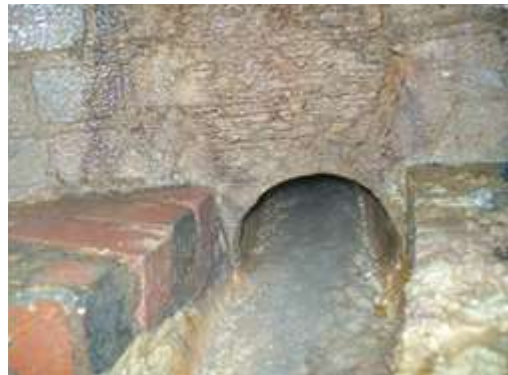
Defect 5

Condition: ☐ Sound ☐ Cracked ☐ Root Intrusion ☐ Deteriorated ☐ Leaks ☒ **Debris**

GREASE DEPOSITS IN CHANNEL

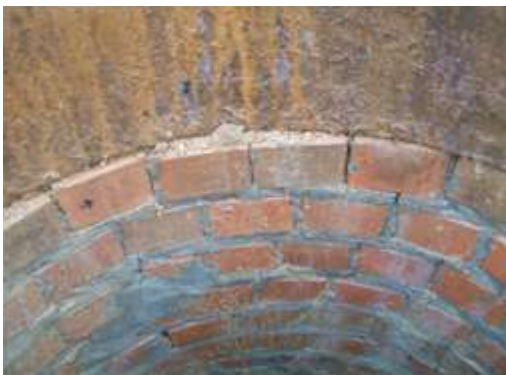
Defect 2

Frame Offset: **0** (in.) Condition: ☐ Sound ☐ Cracked ☒ **Leaks**

FRAME LEAKS

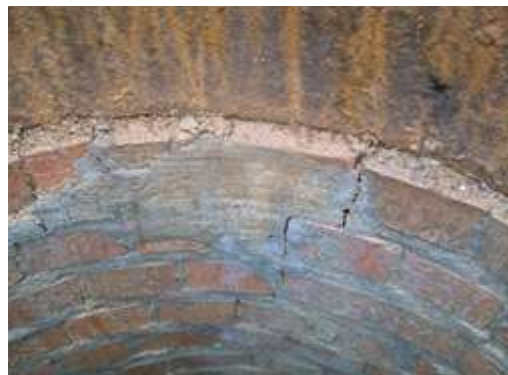
Defect 1

Condition: ☐ Sound ☒ **Cracked** ☐ Root Intrusion ☒ **Loose Brick** ☐ Deteriorated

LOOSE/CRACKED BRICKS

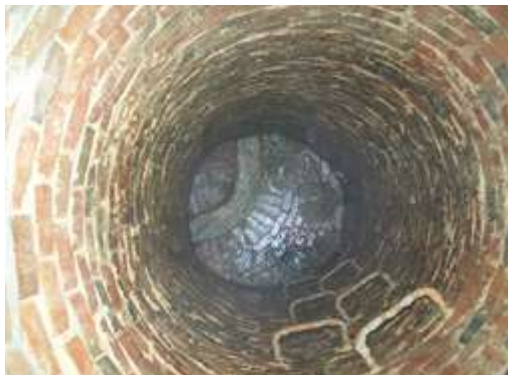
Defect 6

Surcharge ☒ **Evidence Of Surcharge** Depth: **4** (ft.) ☐ Active Surcharge Present

Surcharge evidence

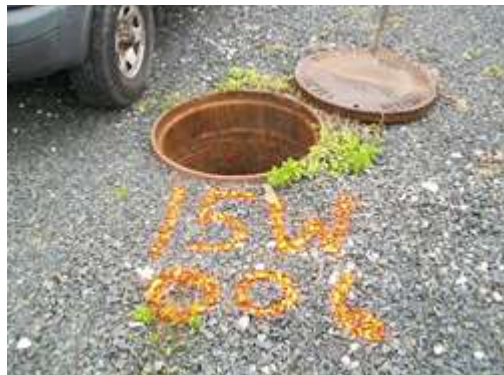
Defect 4

frame above graveled surface

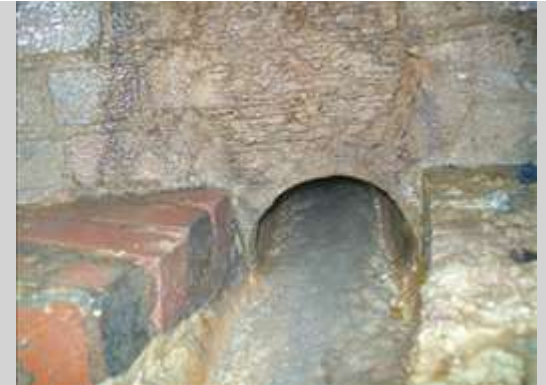
12 O'Clock Outflow

Deposits: ☐ None ☐ Mud ☐ Sludge ☐ Debris ☒ **Grease**

Silt Depth: **1.5** (in.) Deposits Extent: **Light**

Infiltration: **Evidence** Pipe Seal Cond: **Sound**

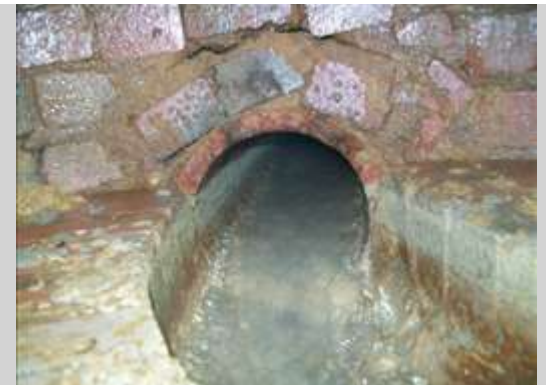
8 O'Clock Inflow

Deposits: ☐ None ☐ Mud ☐ Sludge ☐ Debris ☒ **Grease**

Silt Depth: **1** (in.) Deposits Extent: **Light**

Infiltration: **None** Pipe Seal Cond: **Cracked**
